## DAMAGE MECHANISMS OF HEAVY LOAD WHEELS IN LOGISTIC APPLICATIONS

B. Künne and A. Langenohl

*Keywords: heavy load wheels, damage mechanisms, wear, heat-build up, tread delamination*

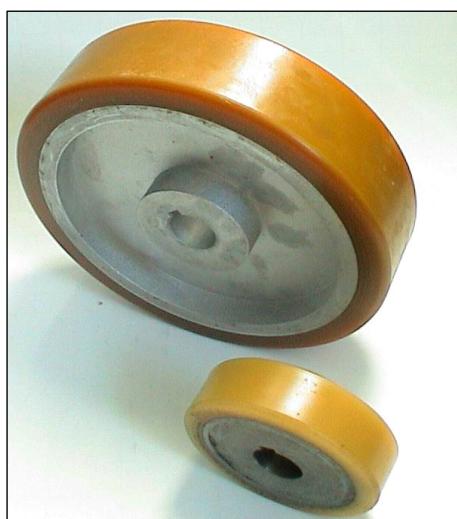
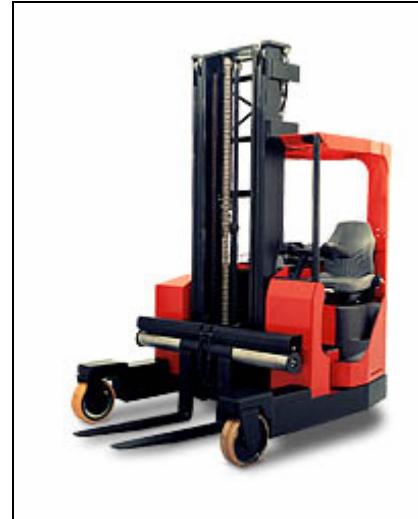
**Figure 1. Heavy load wheels diameter 200 and 100 mm, example of use**

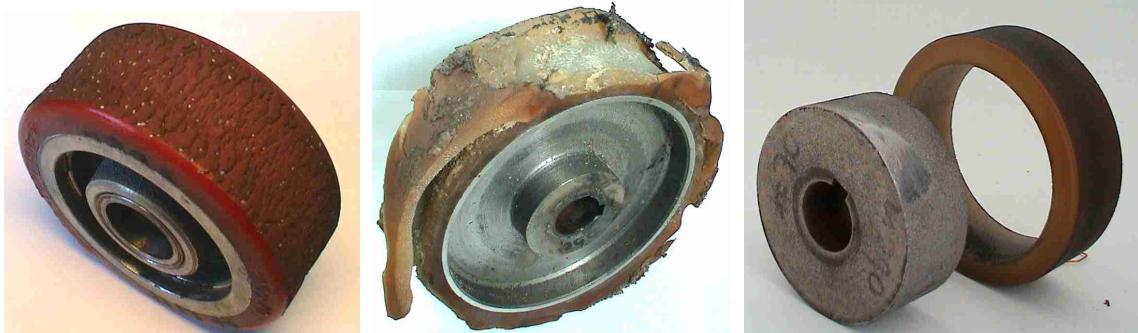
Depending on the kind of load and the external boundary conditions heavy load wheels with solid polyeruthane tyre can fail through abrasive wear, thermal failure, or tread delamination (Figure 2).

**Figure 2. Different failure forms: Abrasive wear, thermal failure, tread delamination**
